SUCCESS STORY

RB SPECIAL CONSTRUCTION

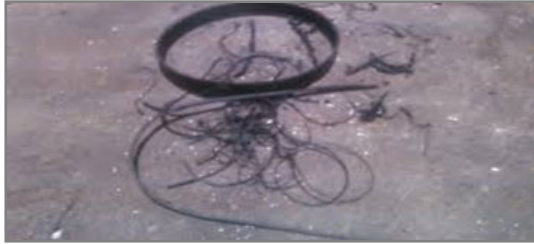
Failed belts that split between the ribs

Optibelt RB – PJ profile Ribbed Belt

- Increased belt life by over 20%.
- Increased machine uptime.
- Elimination of premature rib separation failures.
- Increased the belt's resistance to oil and chemicals

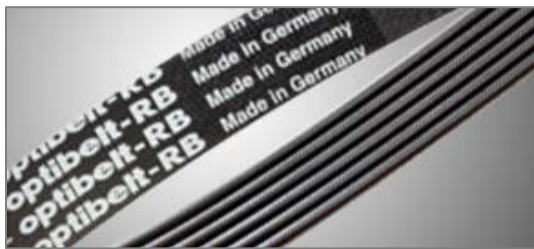
A manufacturer of CNC machines wanted to improve the performance and reliability of their machines. Belts were lasting an average of 400 hours and were failing by separating between the ribs.

The Optibelt RB was specially designed for this application and has shown the following improvements:
